CONFIDENTIAL TESTING REPORT

Current Composites

TECHNICAL REPORT

The goal of this analysis was to determine tensile strength of the applied SR1000 product according to ASTM D882. Table 1 lists the result from the tensile strength tests.

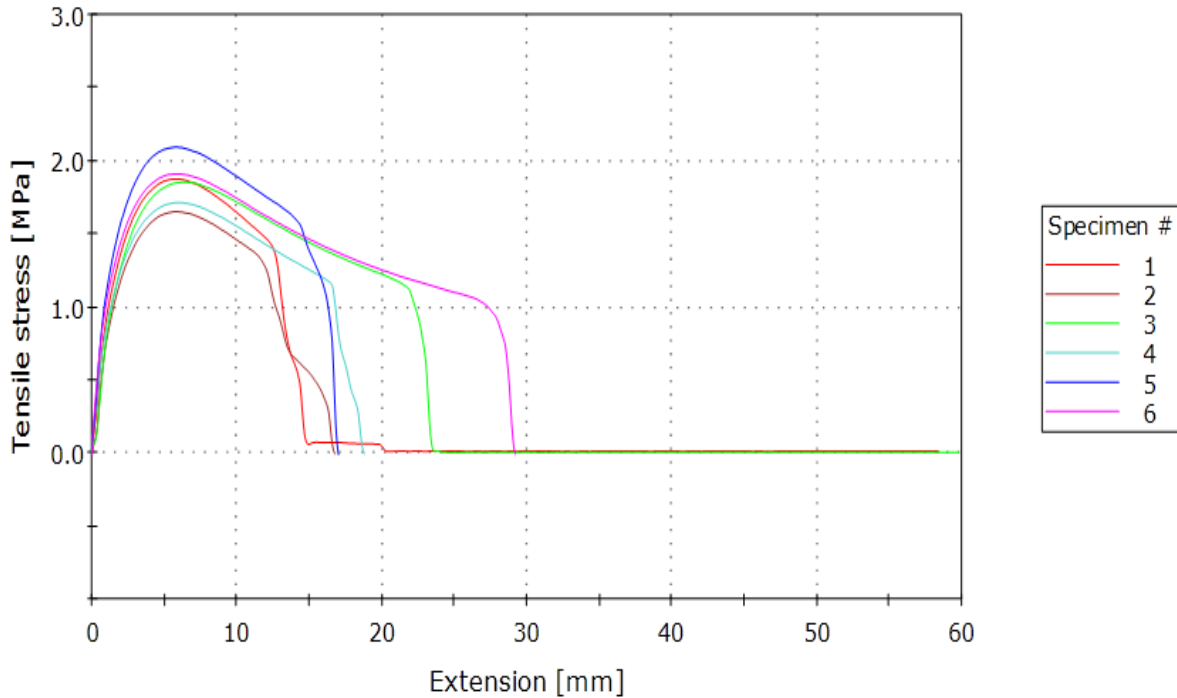
Figure 1: Sample Product Stress-Strain Curve

The results of the tensile strength test for SR1000 after being applied to a 1mm thickness are listed in Table 2. Figure 1 is a graphic demonstration of the tensile strength at yield and stress test results; each of the specimens represents a different 1mm coated sample. Differences in tensile stress at yield values between specimens are likely a reflection of sample coating irregularities.

The sample product was coated in 1mm thickness onto strips of wax paper. The product was tested with an Instron 5965 with a 5kN capacity; the elongation at yield and breaking point capacity were measured.
